Exploration Rehabilitation in Native Woodland

Close-spaced drilling in heavily timbered environments can cause significant disturbance to soil, shrub and tree habitat layers. Alkane Resources Ltd has demonstrated successful woodland rehabilitation on its mining lease at Peak Hill.

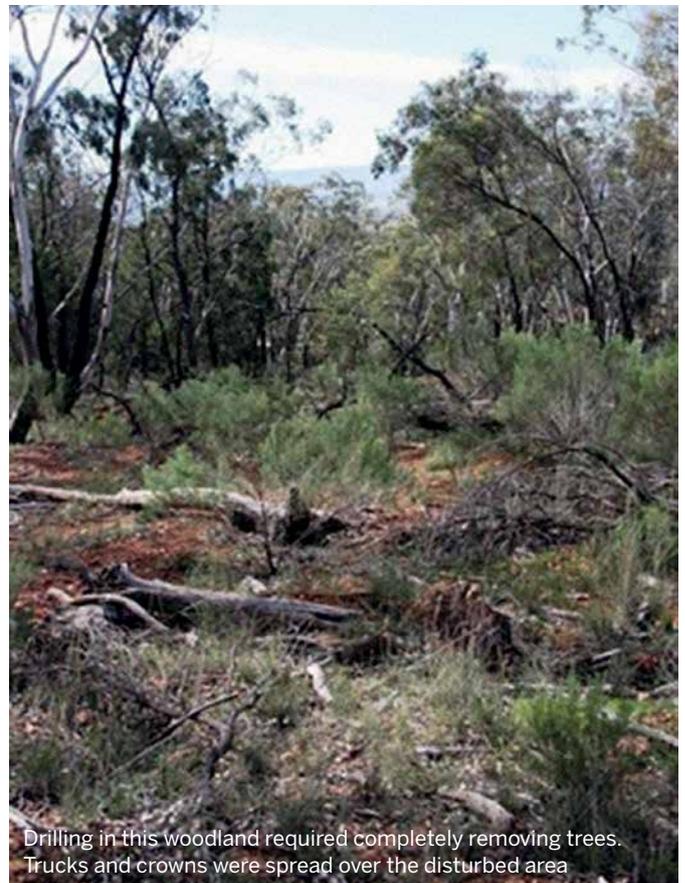
Drilling in this woodland required completely removing trees. Trunks and crowns were spread over the disturbed area

Once drilling was complete, the land surface was restored as soon as possible. Subsoil and topsoil were returned and the trunks and crowns that had been stockpiled were spread over the disturbed area. Again, the equipment was matched to the task.

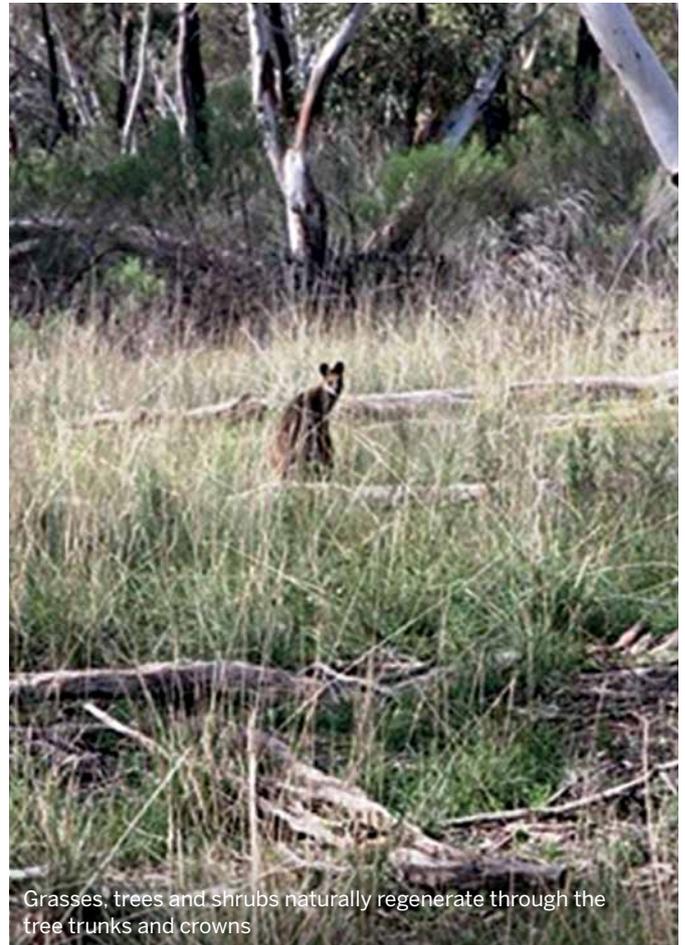
Grasses, trees and shrubs naturally regenerate through the tree trunks and crowns

As for any native woodland rehabilitation project, introduced pasture species were avoided. Adequate native species were naturally contained within the topsoil, which had been stockpiled correctly for the minimum period necessary. Roughing the surface created microhabitats for native plants and animals to re-establish.
